Manhole Inspection Summary

Manhole # S17G__005MH

Insp Date: **10/5/07 10:08 AM**

Location Address: **2327 LEXINGTON-VINE**

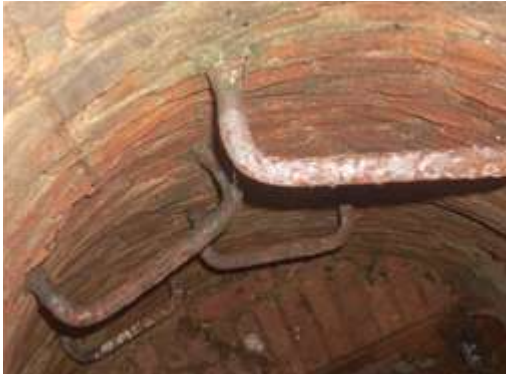
Defect 5

Steps Count: **4** Missing: **0** ☒ **Corroded**

CORRODED STEPS

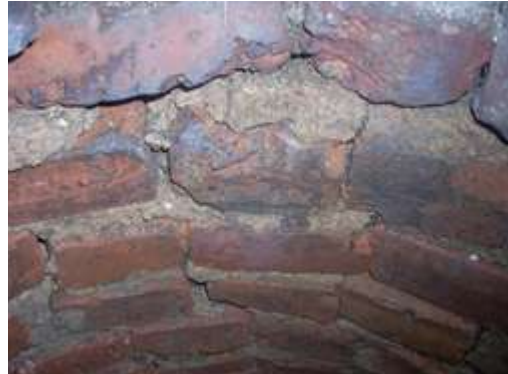
Defect 4

Condition: ☐ Sound ☐ Cracked ☐ Root Intrusion ☐ Loose Brick ☒ **Deteriorated**

CORBEL DETERIORATION

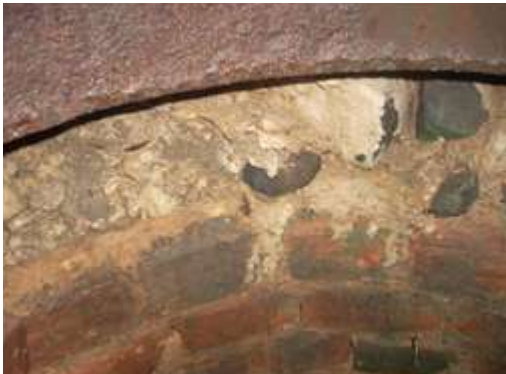
Defect 3

Condition: ☐ Sound ☐ Cracked ☐ Root Intrusion ☒ **Loose Brick** ☒ **Deteriorated**

DETERIORATION OF THE CHIMNEY

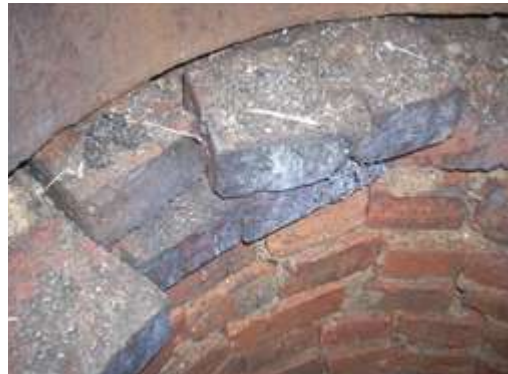
Defect 2

LOOSE CHIMNEY BRICKS

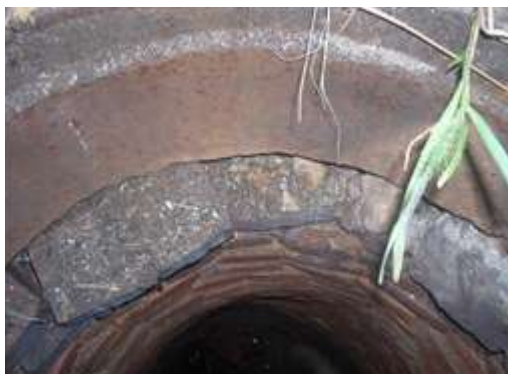
Defect 1

Frame Offset: **2** (in.) Condition: ☒ Sound ☐ Cracked ☐ Leaks

FRAME OFFSET

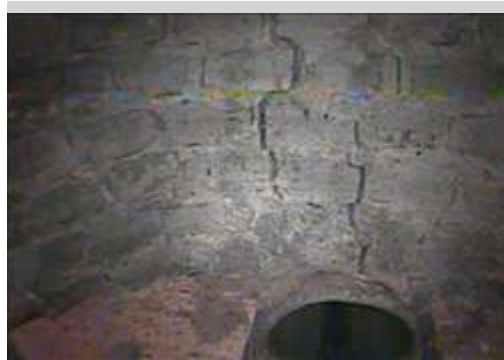
Defect 6

Condition: ☐ Sound ☒ **Cracked** ☐ Root Intrusion ☐ Loose Brick ☐ Deteriorated

CRACKED BARREL

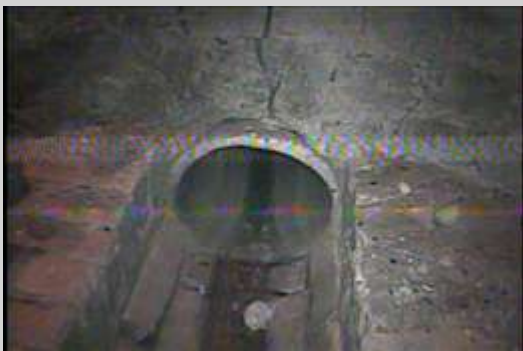
6 O'Clock Inflow

Pipe Height: **8.4** (in.) Rod and Bar (Angled)
Pipe Material: **Clay** ☐ Pipe Lined
Invert Depth: **9.54** (ft.) Flow Characteristics: **Slow**
Deposits: ☒ None ☐ Mud ☐ Sludge ☐ Debris ☐ Grease
Silt Depth: (in.) Deposits Extent:
Infiltration: **None** Pipe Seal Cond: **Cracked**
